**CULTURAL RESOURCES OFFICE
PRESERVATION BOARD
REGULAR MEETING
MONDAY MARCH 22ND, 2010
1015 LOCUST ST. #1200
4:00 P.M.**

Date: March 22, 2010
To: City of St. Louis Preservation Board
From: Bob Bettis, Preservation Planner
Subject: Preliminary Review to construct an attached garage
Address: 1913 California Avenue
District: Fox Park Neighborhood Historic District — Ward 6

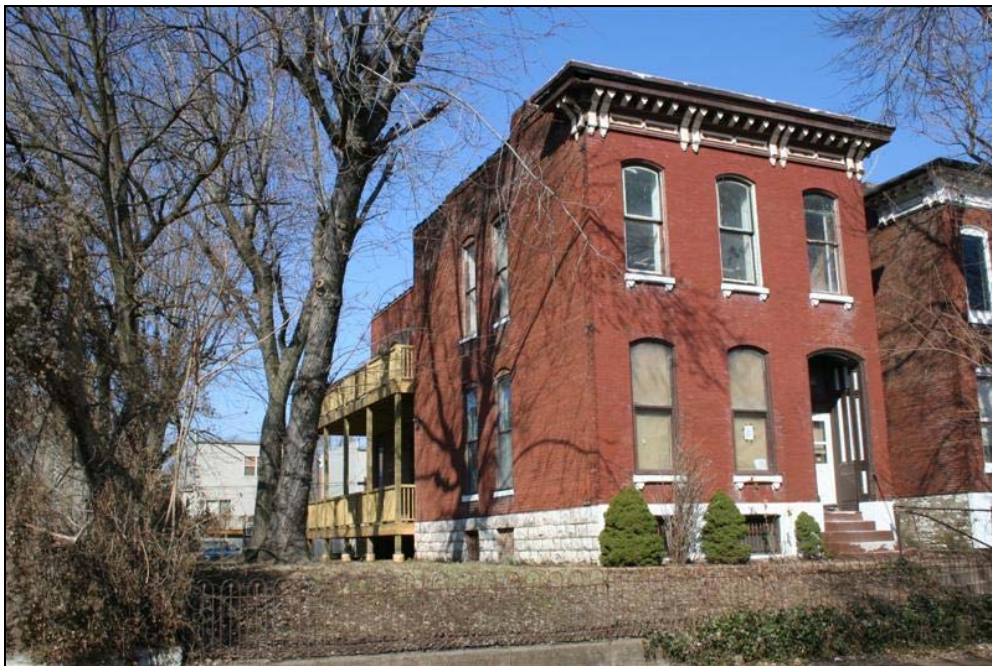
1913 CALIFORNIA AVENUE

Purpose:
To construct a three car attached garage

Recommendation:
The Preservation Board should deny the Preliminary Application as the proposed garage does not comply with the historic district standards.

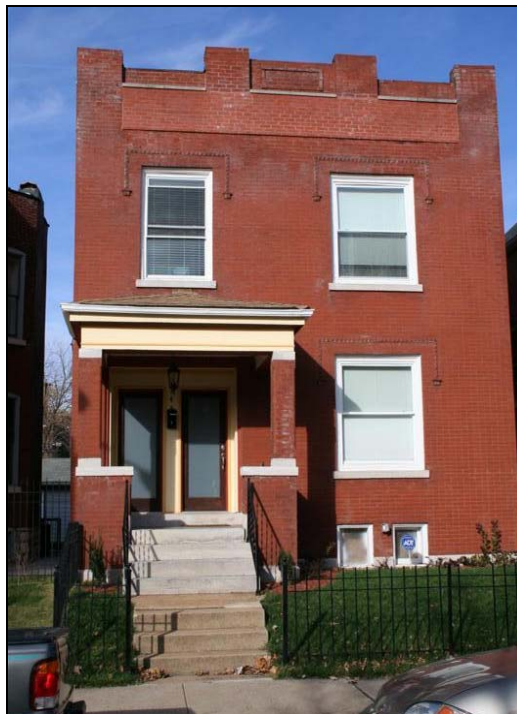
2745 ACCOMAC AVENUE

On May 15, 2009, the Cultural Resources Office received a Citizens Service Bureau complaint for work being completed at 2745 Accomac Ave. without a permit. Upon inspection it was discovered that two new front doors had been installed, and both original transoms and trim were removed. The owner of the property did not respond to correspondence from the Cultural Resources Office and was referred to Housing Court. Upon receipt of a court summons, the owner made application for the non-compliant work on September 8, 2009.

The Preservation Board should deny the Preliminary Application as the proposed work does not comply with the historic district standards.

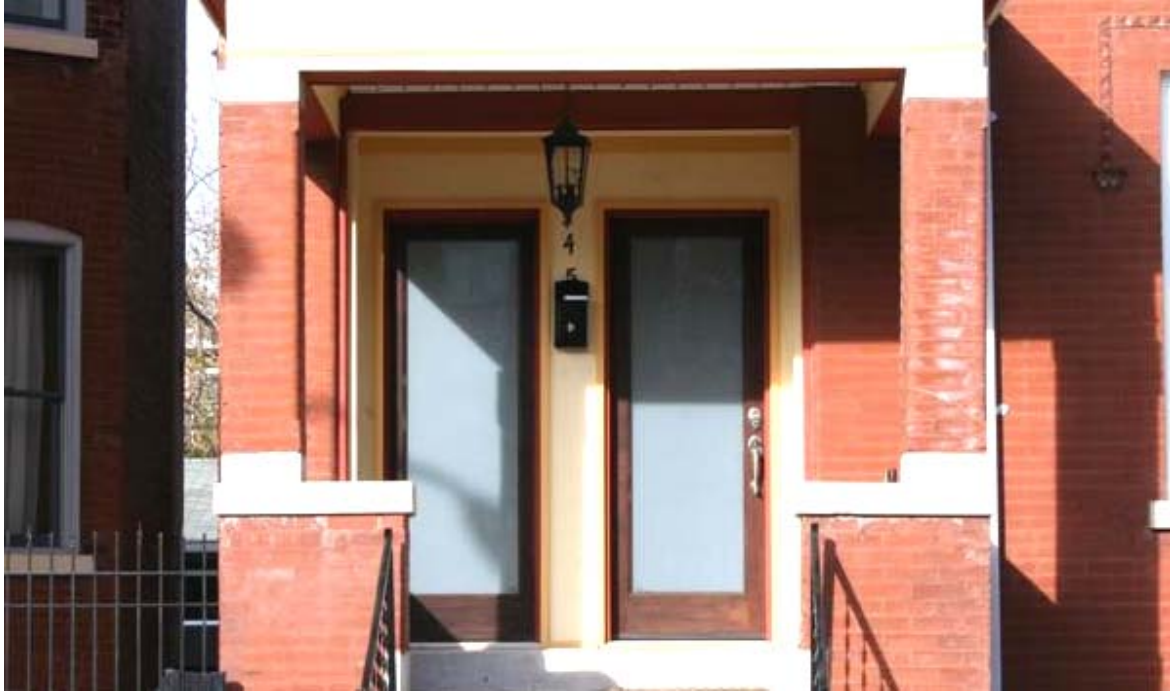
DETAIL OF NEW DOORS

Does not comply. The alterations made to the front entry have completely changed the character of the front entry. The proportions and style of the original doors have been lost; and all of the original door transoms, center mullion and other trim have been removed. The owner did not provide a Model Example, but he would not be able to, as the renovation of the entry is entirely contemporary in design.

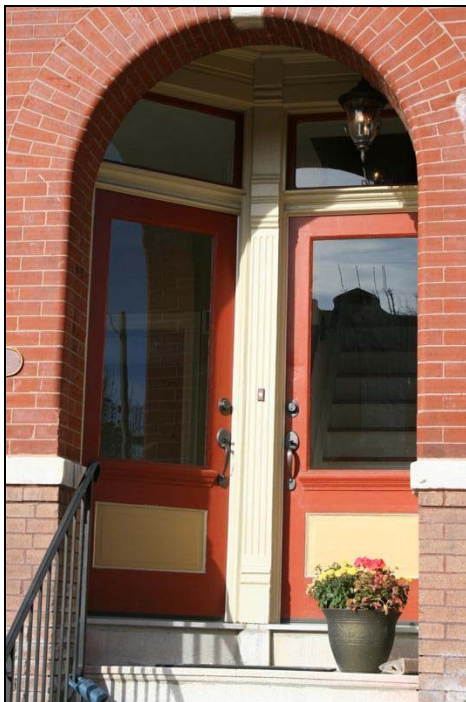
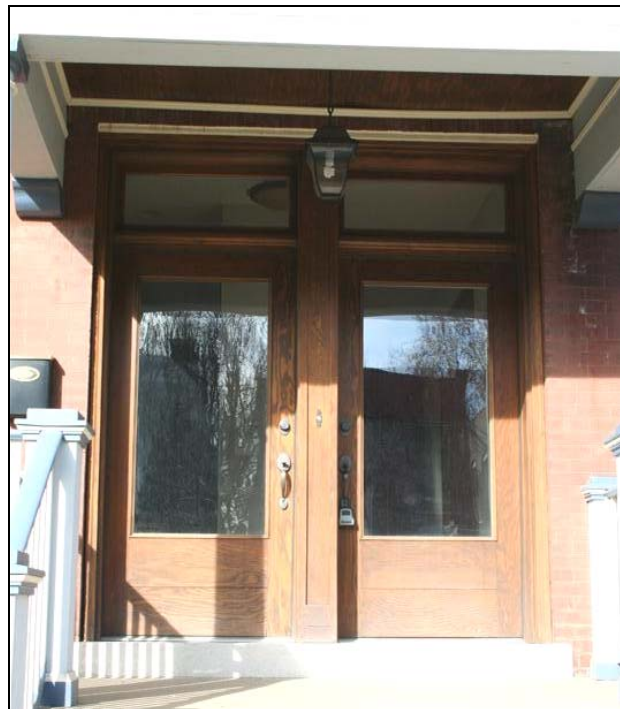
PROPER DOOR CONFIGURATIONS/EXAMPLES

Comment: Doors, like windows, are an integral part of a building's street facade. Primary entrance doors are one of the strongest first impressions of a building. Door types found in the Fox Park Historic District are limited to a few different types. Doors of earlier Federal style buildings are solid, simple in construction and without ornament except for four or six panels. Victorian doors are much more ornate, often with elaborate carvings, recessed panels or other architectural detailing and typically have a glazed area in the upper half to three quarters of the door (See Figure I)

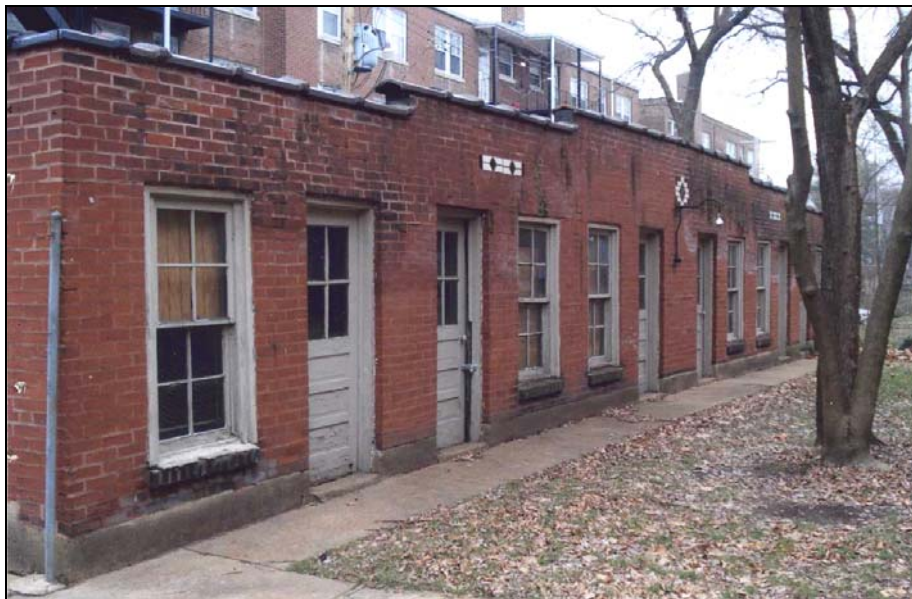
6169 PERSHING AVENUE REAR – AS IT APPEARED BEFORE DEMOLITION

On February 24, 2010, the Cultural Resources Office received an application for the demolition of a one-story, multi-car brick garage at 6169 Pershing. Photos accompanying the application showed that the garage appeared in sound condition, and was stylistically similar to the front building,

The owners stated that the building was in poor condition and needed to be demolished for safety reasons. Based on photographs supplied with the application, the garage appeared to be in sound condition and remarkably intact, with its original multi-light windows and paneled doors. It is also one of the few unaltered examples of early 20th century garages left in the historic district. The Cultural Resources Office staff would have scheduled the demolition application for review by the Preservation Board even had the applicants not proceeded to demolish the building, precluding their review.

The Cultural Resources Office staff recommends that the Preservation Board deny the demolition and refer the owner to Housing Court.

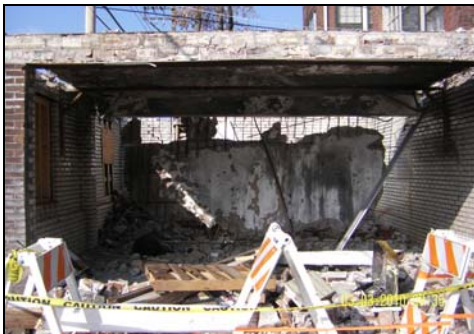
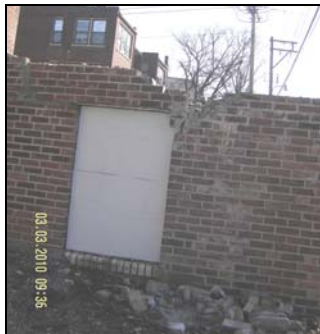
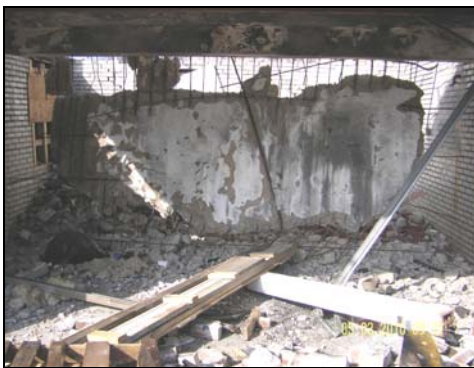
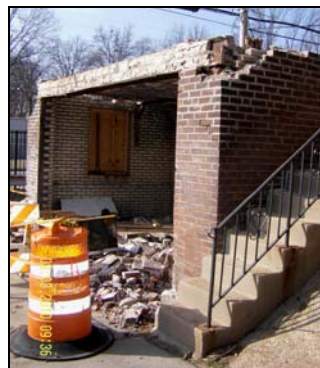
The photos the Office received were those of another garage, at 6100 Pershing Rear, which was being demolished at the same time by the same contractor. These are those photos:

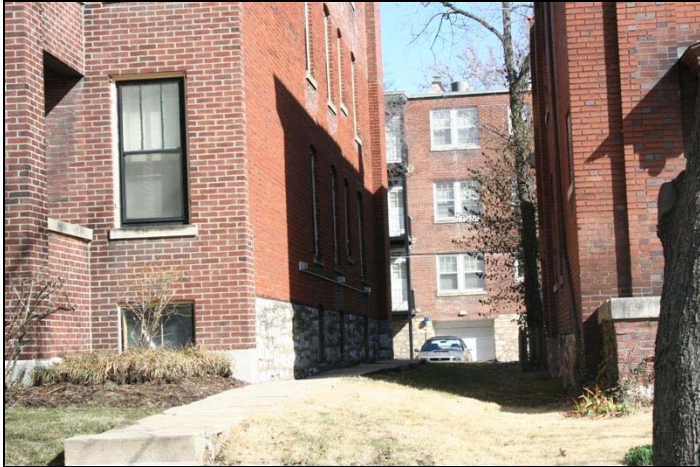
GANGWAY WEST OF 6169 PERSHING SHOWING THAT GARAGE WAS PARTIALLY VISIBLE FROM PERSHING

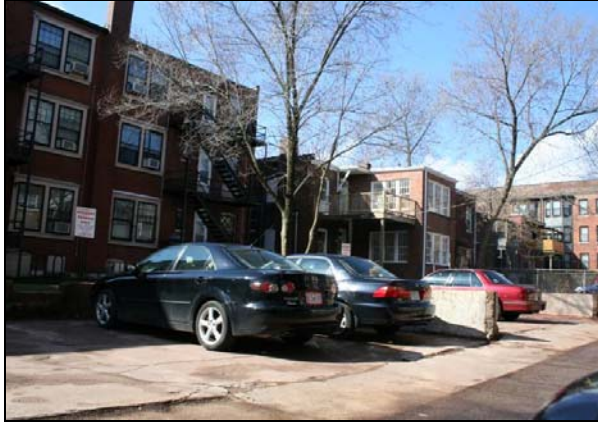
The following day, the Cultural Resources Office received a letter from Aalco Wrecking, stating that their subcontractor had “jumped the gun” and begun demolition without a permit. When the staff visited 6169 Pershing on the following day, the garage was entirely demolished, the site cleaned, and tenants were parking between the concrete foundations.

CURRENT SITE CONDITIONS

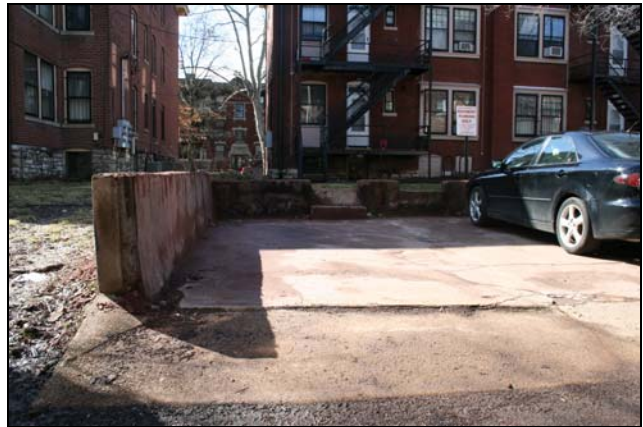
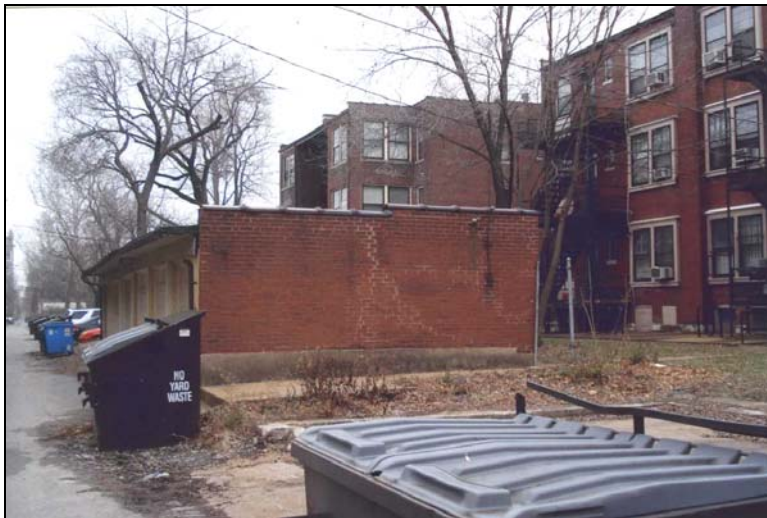
PRIOR TO DEMOLITION

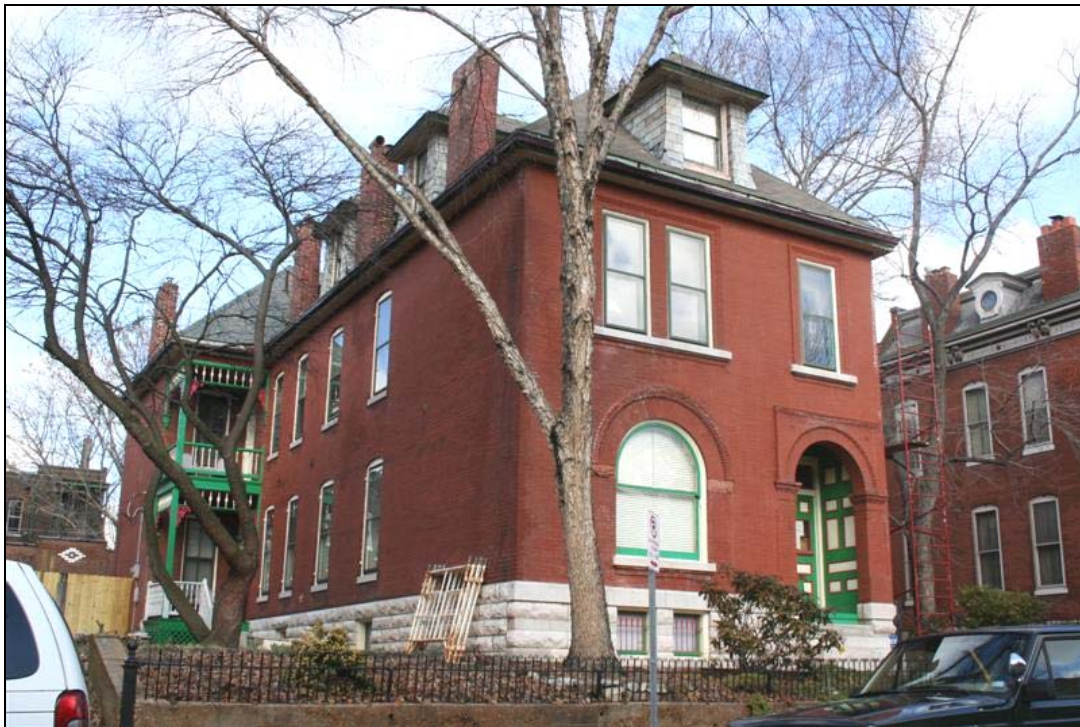
2407 S. 13th STREET

On July 31, 2009, the property owner applied for a permit to replace the roof and gutters on his 2-1/2 story single-family house in the Soulard Historic District. In December, he was cited by the Building Division for alterations to the rear dormer and removal of a rear chimney, work which was not included on his approved permit. The dormer's original slate shingles had been removed from the dormer and replaced with horizontal lap siding. The owner intends to do the same with the remaining five

dormers, all of which are prominently visible from the street. He also proposes to remove the four large chimneys on the south side of the house. As this work did not conform to the Soulard Local Historic District standards, the application was denied by staff. The owner appealed the denial in January and the project was scheduled for the February meeting. Shortly before, the owner asked for a deferral, and it was re-scheduled for the March agenda.

Recommendation:
That the Preservation Board uphold the staff denial as the proposed work does not conform to the Soulard Local Historic District design guidelines.

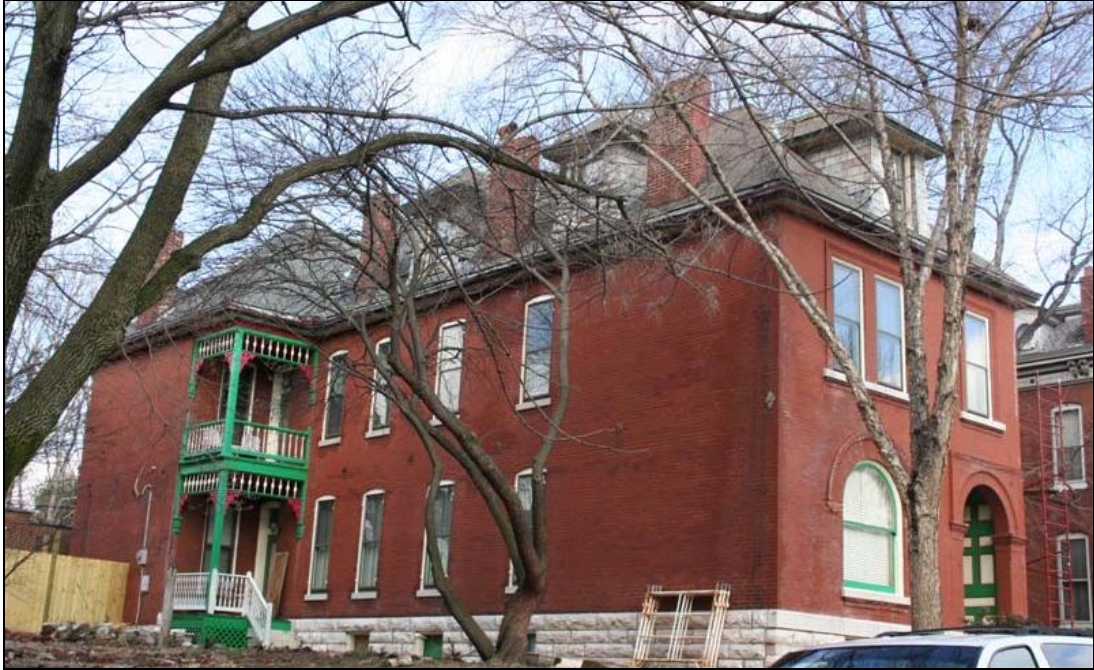
SOUTH ELEVATION

Does not comply. The chimneys are critical to the architectural character of the house and form a distinct decorative element with the dormers on the south elevation.

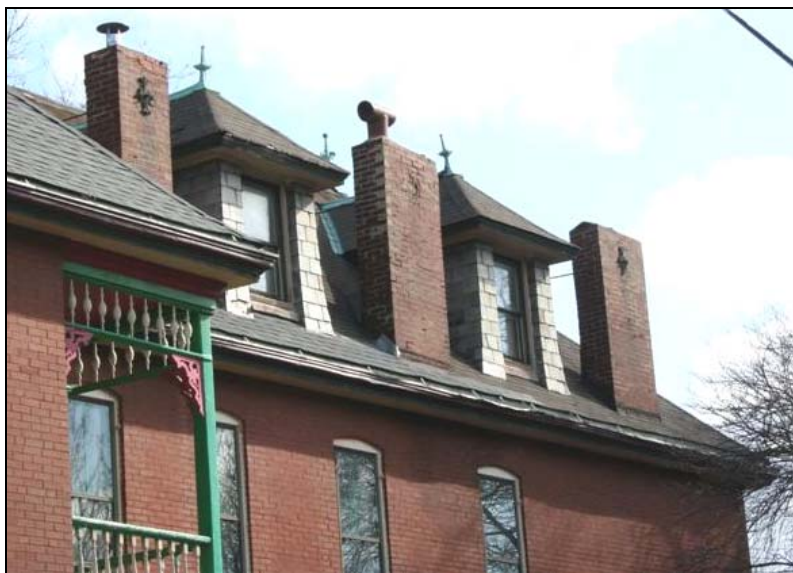
DETAIL OF DORMERS AND CHIMNEYS ON SOUTH ELEVATION

Chimneys: Again, the Standards are clear that chimneys are a significant element of historic buildings and are not to be removed or altered, but reconstructed if their necessary. The owner has presented no evidence for his statement in his appeal that, “It is obvious the chimneys are way past repairing.” From exterior inspection, this does not seem to be the case.

Staff recommends that the Preservation Board uphold staff denial as the proposed work does not conform to the Soulard Local Historic district standards.

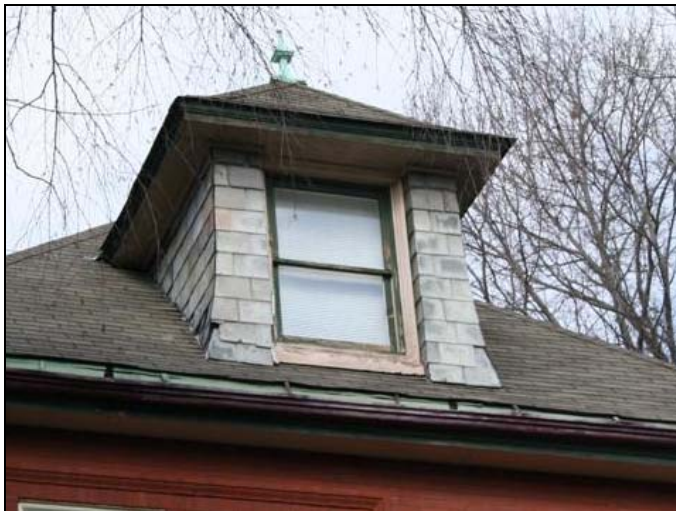
ORIGINAL DORMER AT FRONT FACADE

Does not comply: The dormers retain their original slate. The owner's intent will adversely affect the appearance of the dormers and roof, as illustrated below.

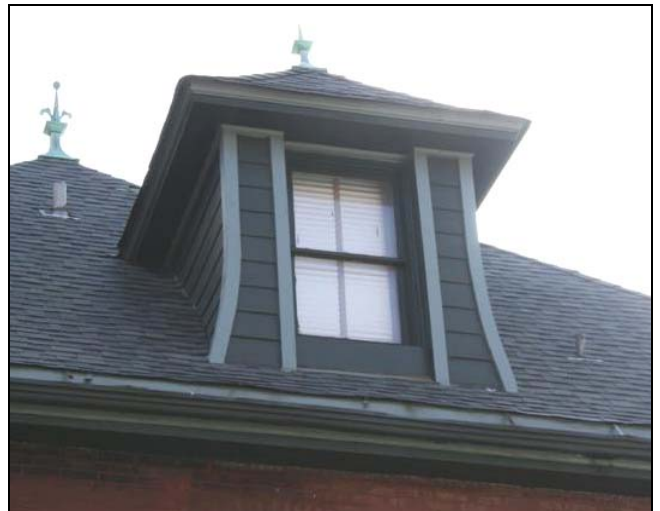
REAR DORMER WITH ALTERATIONS

The historic district standards are correct in stating that asphalt shingles are not recommended for installation on a vertical service. The owner has submitted no evidence that the slate on the dormers is irreparable; on the contrary, the water problems seem rather to be related to failure of flashing. However, if the slate cannot be salvaged and repaired, there are many new products such as Lamarite that do a good job of replicating the appearance of slate and would blend far better with the composition shingles of the existing roof.

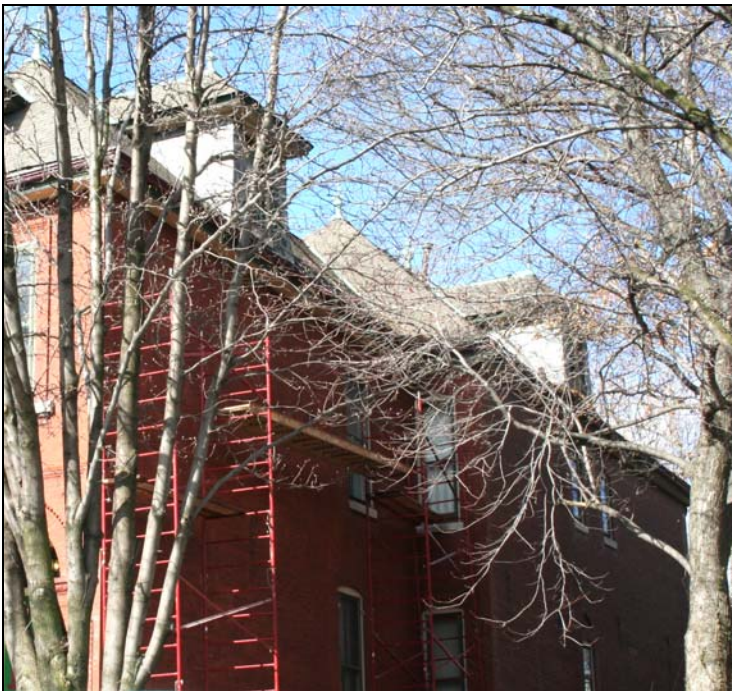
NORTH ELEVATION

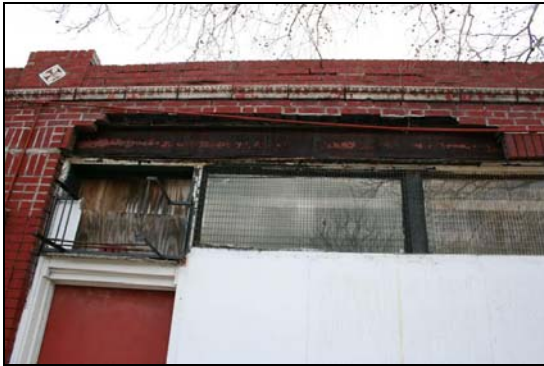
FAILURE ABOVE CENTER STOREFRONT

The building has suffered from lack of maintenance, but it is still a sound building under definition of the ordinance. In the staff's experience, the building could be successfully rehabilitated, especially given its location in the Central West End. The building is a contributing resource to the Central West End Local Historic District and its demolition would degrade the integrity of this end of the district. The building(s) on the northern end of the lot at 4260 Westminster were demolished some time in the past. The building facing Boyle, with its street presence, anchors this end of the

The applicant has not provided evidence supporting the decision to demolish the existing building as opposed to rehabilitation. The Cultural Resources Office recommends that the Board uphold the staff denial of the application for demolition.

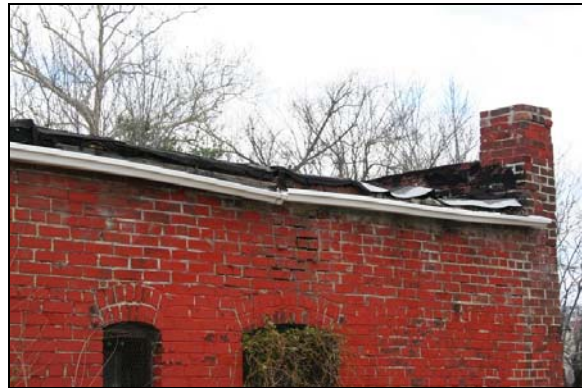
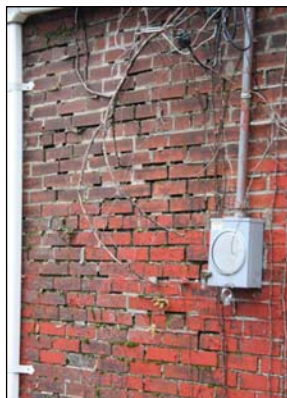
MORTAR LOSS AT REAR WALL

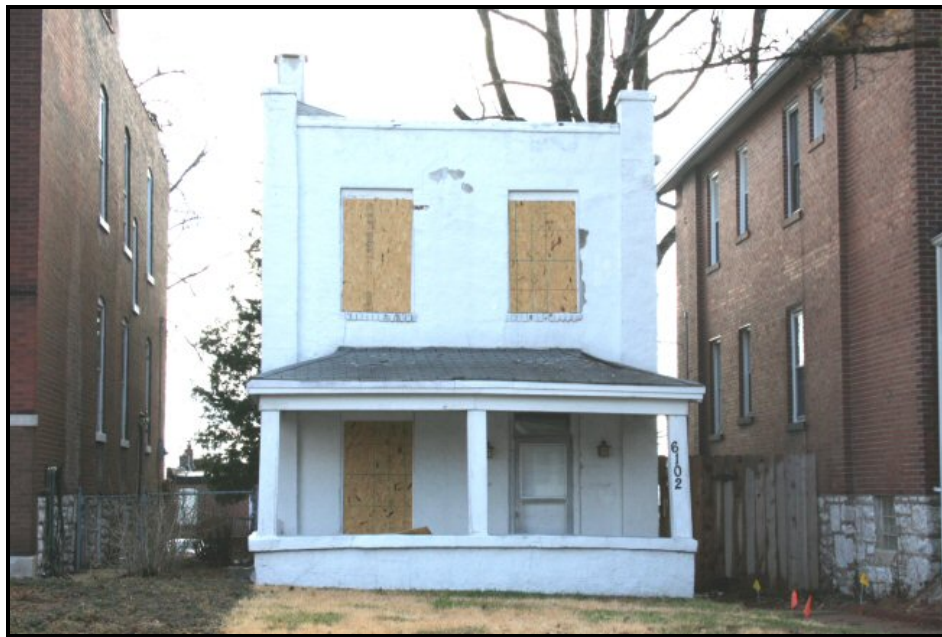
6102 MICHIGAN

Visual inspection of the exterior of the building revealed no obvious structural defects.

In addition, the building appears to be an early 19th Century structure, with a flounder roof and rear. The front of the building was most likely “re-modeled” sometime in the early 20th Century to have a more Arts and Crafts appearance; however the original flounder roof and chimney are clearly visible from the street.

Staff recommends that the Preservation Board uphold the staff denial of the application for a building permit.

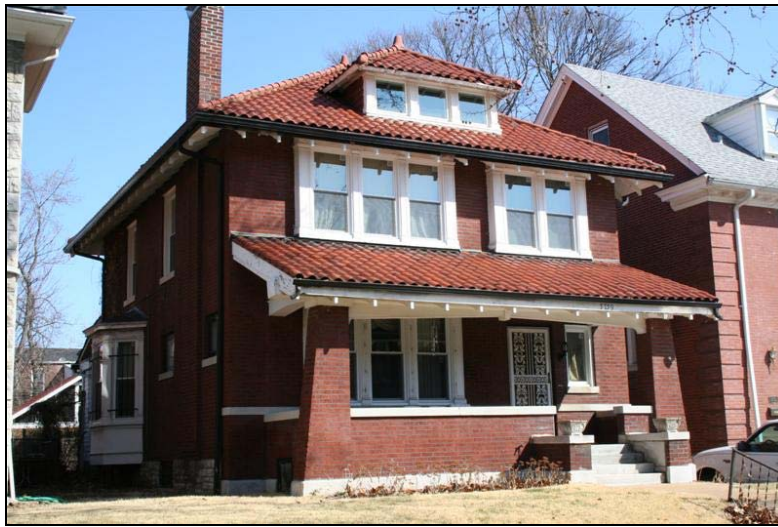
5759 WATERMAN

Does not comply. Replacement windows installed do not replicate the proportions and appearance of the original windows; in addition, the wrapping of brick molds, sills, and mullions have greatly altered the building’s historic appearance.

Recommendation:
That the Preservation Board uphold the Staff denial as the installed vinyl windows do not meet the Skinker-DeBaliviere Historic District Standards. On the main facade, the owner should be instructed to install appropriate replacement windows, and to remove all wrapping on sills, brickmold, and mullions.

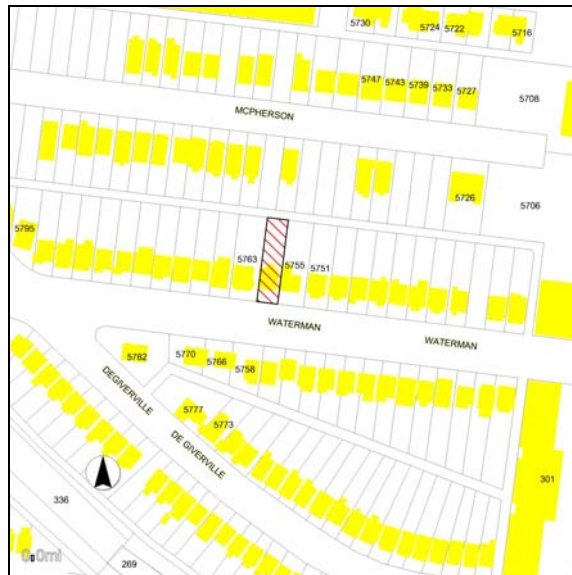
A citizen's service bureau complaint was investigated in January of 2010. Upon inspection it was discovered that vinyl windows had been installed on the front of the building without a permit. The owners applied for a permit on February 12, 2010 to retain vinyl windows. As the vinyl windows do not meet the Skinker-Debaliviere Historic District standards and no remedy could be reached with the owner, the permit was denied.

The Cultural Resources Office recommends that the Preservation Board uphold the staff denial of the application as the vinyl windows do not meet the Skinker-DeBaliviere Historic District Standards. On the main facade, the owner should be instructed to install appropriate replacement windows, and to remove all wrapping on sills, brickmold, and mullions. The applicant may retain the vinyl windows on the sides and rear.

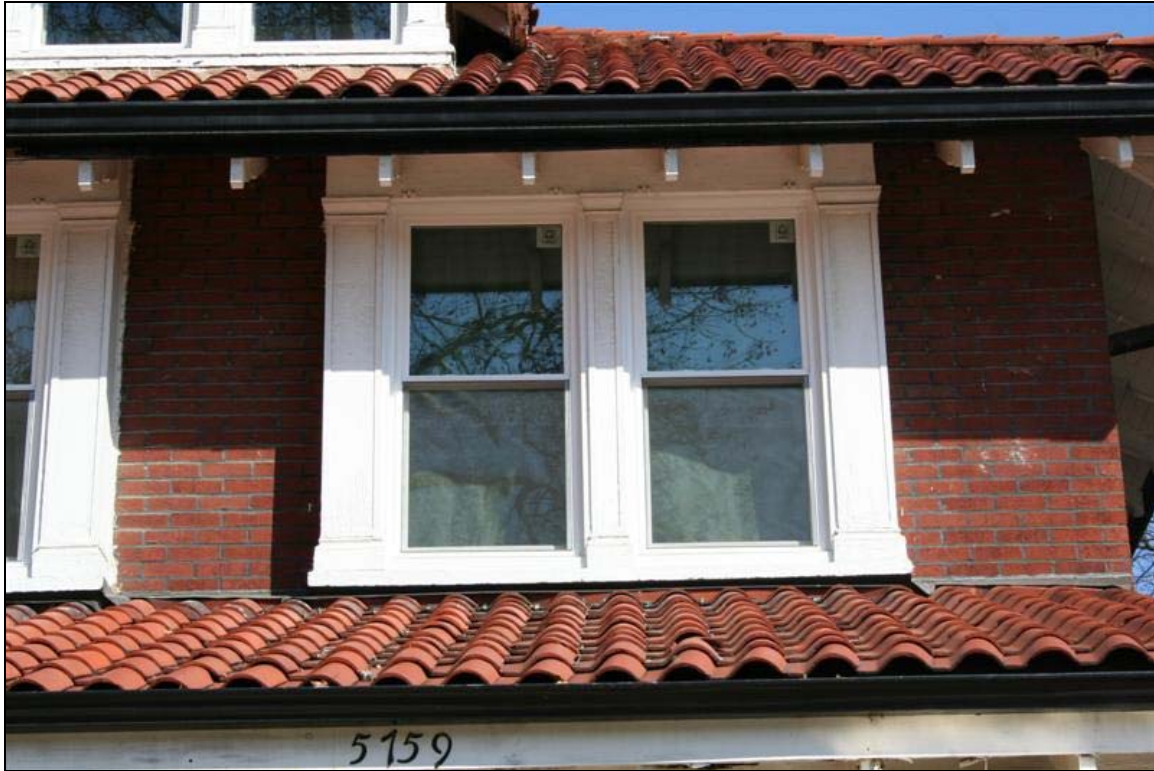
DETAIL OF WINDOW ON FRONT FACADE

5759 Waterman, built in 1919, is a Craftsman style building. The Craftsman style was noted for a simplified design that emphasized traditional building methods and handcrafts. Much of the architectural expression for this building style is found in the design of windows and doors. The vinyl windows installed by the owner have seriously affected the building's historic character and integrity. The windows are flat and contemporary in appearance; the lift and meeting rails are narrower, and the jambs are wider than the original window.

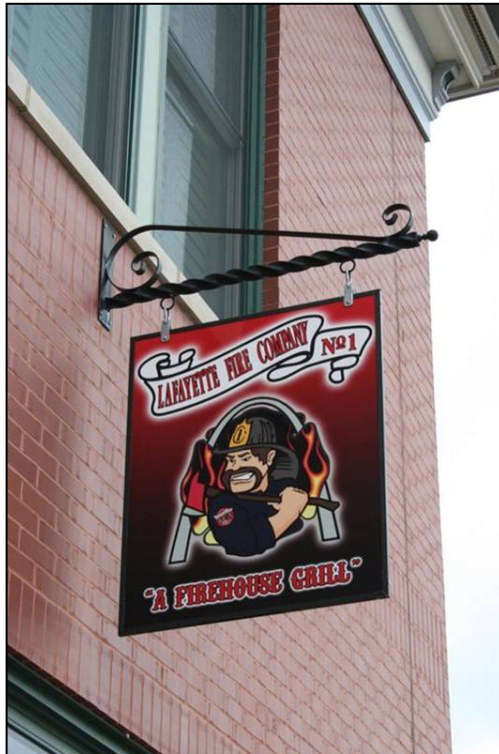
PROJECTING SIGN

In February 2010, the Cultural Resources Office received a permit application for signage at 1801 Park. The signage included one projecting sign above the storefront and three (3) window signs located in the transom area. The signage was installed without a permit. The Cultural Resources Office issued an administrative denial of the permit application and the owner has appealed that decision.

Recommendation:
That the Preservation Board uphold the staff denial of the signage as it does not meet the Lafayette Square Local Historic District Standards.

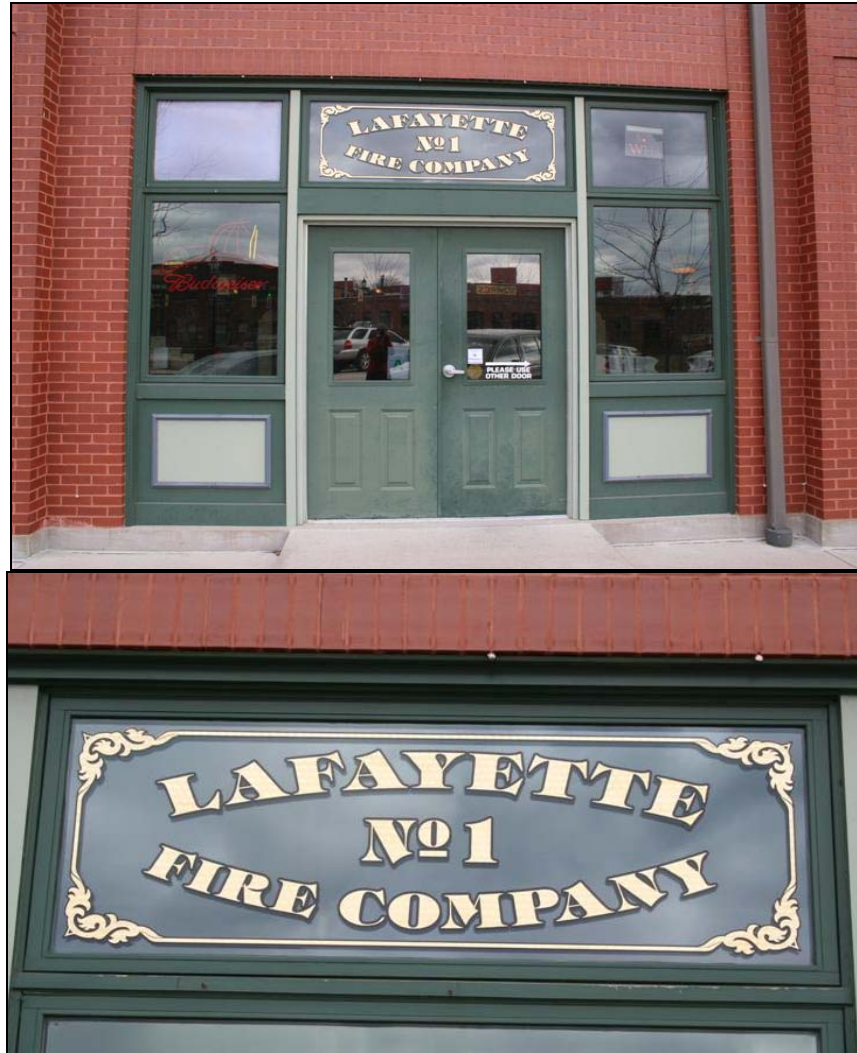
EXAMPLES OF TRANSOM SIGNAGE

6. Signage may be painted on the storefront glass, height of letters not to exceed 6". Sign not to exceed 2 lines. **Current signage on transom windows meet the letter height requirements, but are three lines of text.**
